100 THE COMMITTEE OF ONE HUNDRED

NEWSLETTER

The Restoration of the Museum of Art Entry

Museum of Art Restoration

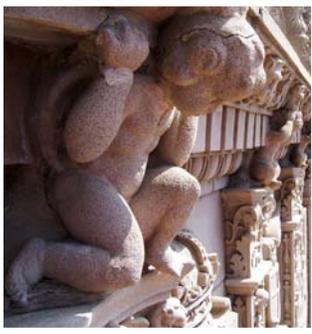
Detail of Cornice showing elaborate figures and an example of cracking.

The laboratory results were equally distressing. The concrete was deteriorating and the steel bars in the cast-stone were rusting at exposed locations. As the embedded bars rusted, they expanded and cracked the cast-stone allowing even more moisture to enter into the wall. Sometimes the cracking resulted in pieces becoming loose and falling. The team considered that

for the cracking and the poor support were severe and led to the decision to recommend removal and replacement of most of the frontispiece—not an easy decision when proposing such a difficult replacement. The more protected center portion above the entry doors and statue alcoves was in significantly better condition and retained in accordance with the *Standards*. Special stainless steel reinforcing for the new cast-stone pieces would never rust or damage the panels.

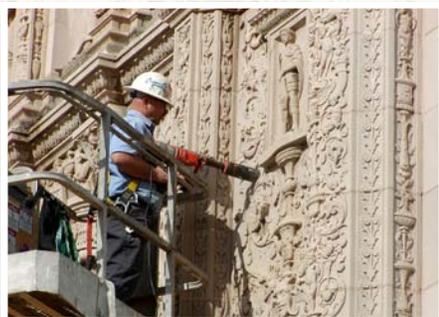
The process of determining the causes and remedies involved coring several holes through the cast-stone in discrete locations. This allowed the team to obtain samples and get a look behind the wall to determine how pieces were attached. A fibrescope, a camera on a long flexible stem, enabled the engineers to get a good look at what was hidden inside the wall cavity. The Museum of Art remained a functioning museum, so making large holes from the inside to get a look at the wall construction was not desired or beneficial because the cast-stone was attached to the opposite side of a double wall. The wall behind the cast-stone was constructed of hollow clay tile that would not provide much support in an earthquake. A better supporting wall would be needed to permanently support a new cast-stone ornamentation

Drilling cast-stone for samples and investigating hidden construction

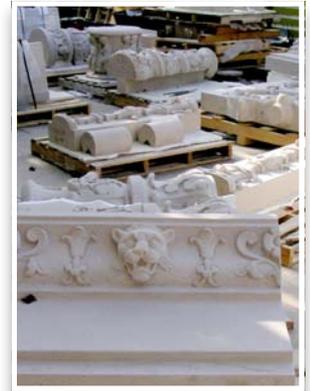
New cast-stone pieces laid out before installation.

The new cast-stone pieces were created from molds made from the original pieces. Replacing cast-stone was a delicate process that required skilled workmen to remove the old cast-stone without further damage and artists to prepare molds and recast the new pieces. The new pieces matched the historic pieces exactly. If the originals were warped or crooked, the new

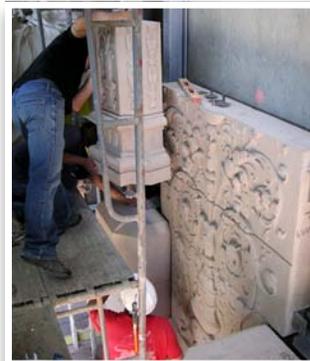
Setting new cast-stone pieces in place.

castings were also warped and crooked. Matching the color to the remaining portion of the frontispiece was challenging because several shades of color existed even in individual pieces and a waterproofing treatment slightly altered the colors. The new concrete back-up wall and a steel support system firmly support both the weight of the wall and resists lateral earthquake movement. The center historic portion with

the statues that remain has been tied back to the new wall and structural frame with stainless steel anchors.

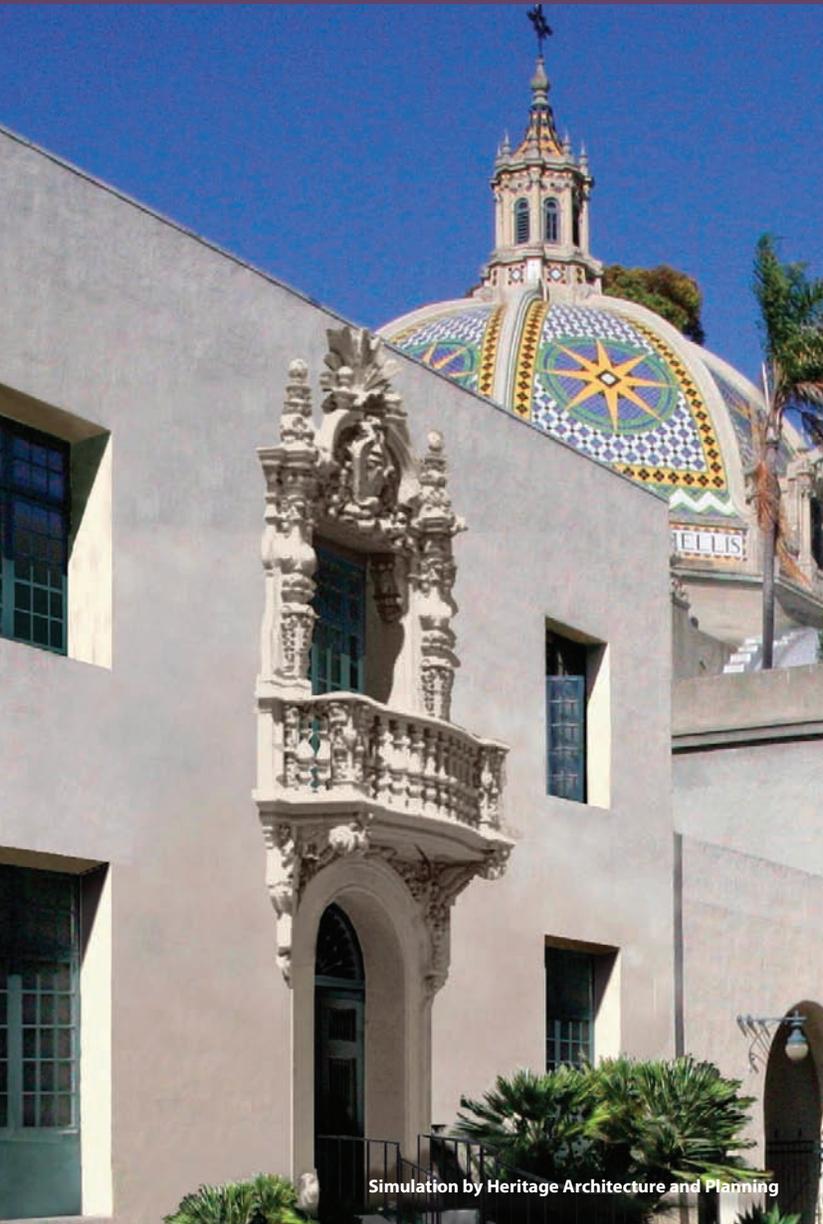
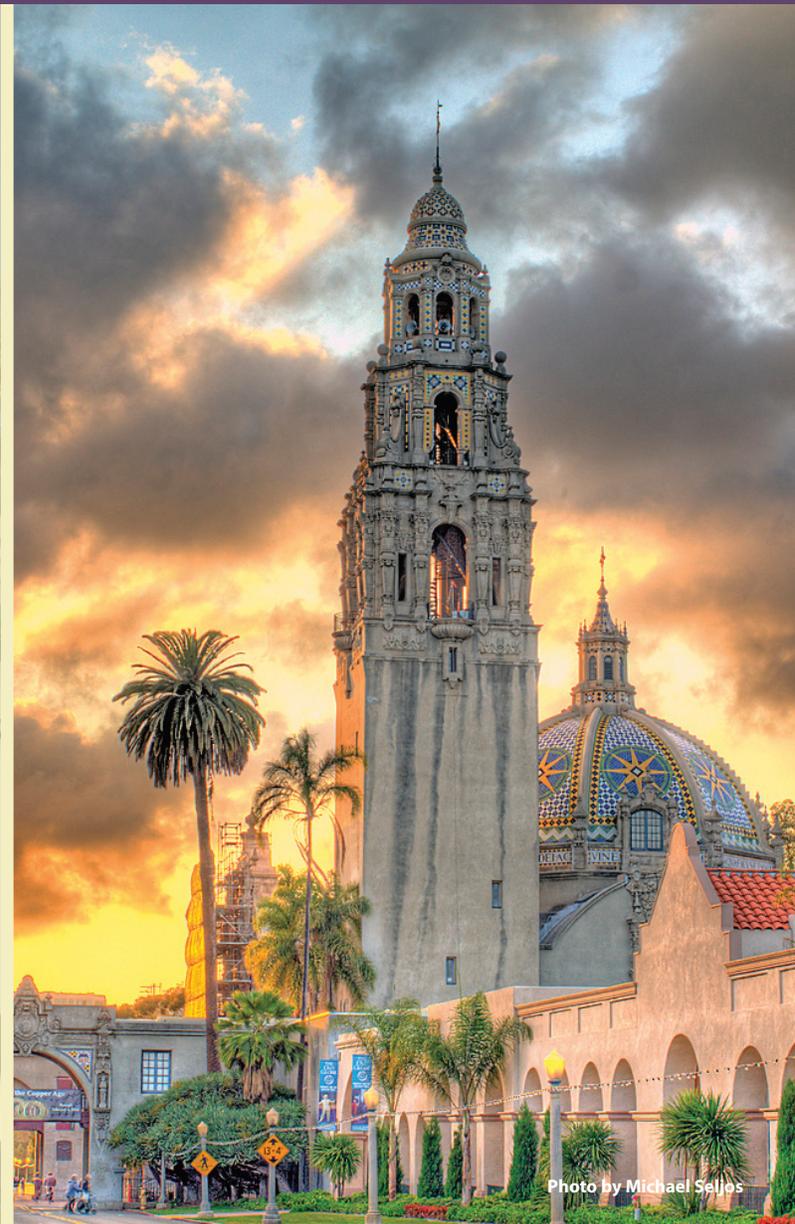
Administration Building Façade

The original ornamentation around and above the entrance to this building has been long missing. The Committee of One Hundred intends to restore the entrance to its original condition as shown in the photo simulation above.
