100 THE COMMITTEE OF ONE HUNDRED

WINTER 2012

Repairing San Diego's Most Historic Roof

by Curtis Drake

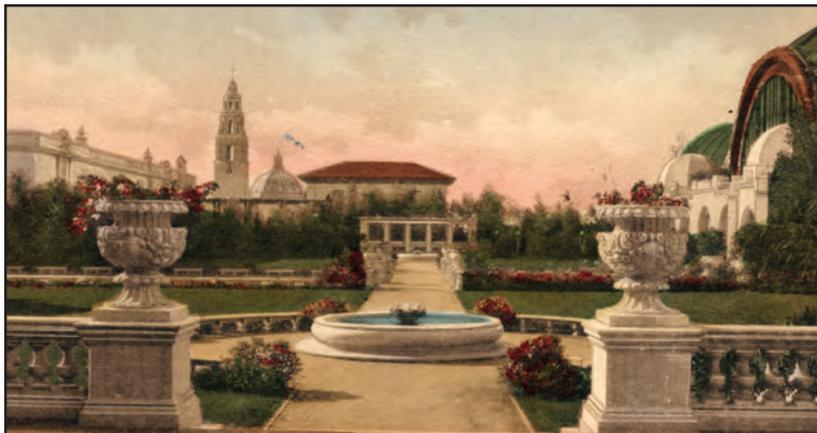
Two identical fountains flanking the front of the Botanical Building trace their origin to the 1915 Panama-California Exposition. No longer working, these empty fountains are a sorry sight, having shed many of the non-historic tiles inside the fountains.

In preparation for the 2015 Centennial celebration, the members of the Balboa Park Alliance (The Committee of One Hundred, the Friends of Balboa Park, and the Balboa Park Trust at the San Diego Foundation) have agreed to correct this unsightly situation. The group will fund the restoration of the fountains, new lighting, and a redesigned water supply and pump system. The result will be a quiet, automatically controlled system that will put these historic fountains back into service. The hand-colored 1915 postcard below shows both fountains, one in the center foreground.

The same postcard also shows a missing arbor directly behind the fountain in the distance. Reconstruction of

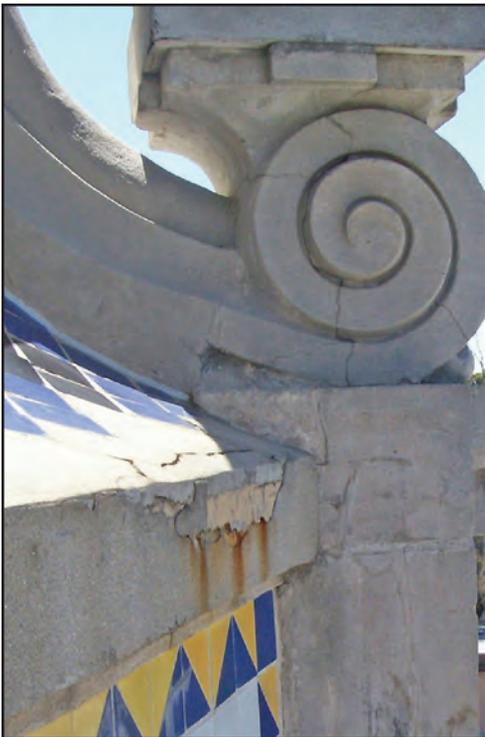
A survey of the building's roof in 2007 indicated that deterioration of cast-stone elements, mortar, and sealants were similar to conditions repaired on the California Tower under my firm's direction several years ago. The cast-stone lantern atop the dome and at the dormers around the base of the dome were cracking, allowing water to move into the stone and corrode reinforcing within and in some cases leak through to interior finishes of the museum. The dome is located above a tar & paper roof that has seen its useful life dissipate over the last ten years. The last time repairs were made to the dome and roofing was

Typical cracks in stonework. Photo by Curtis Drake.

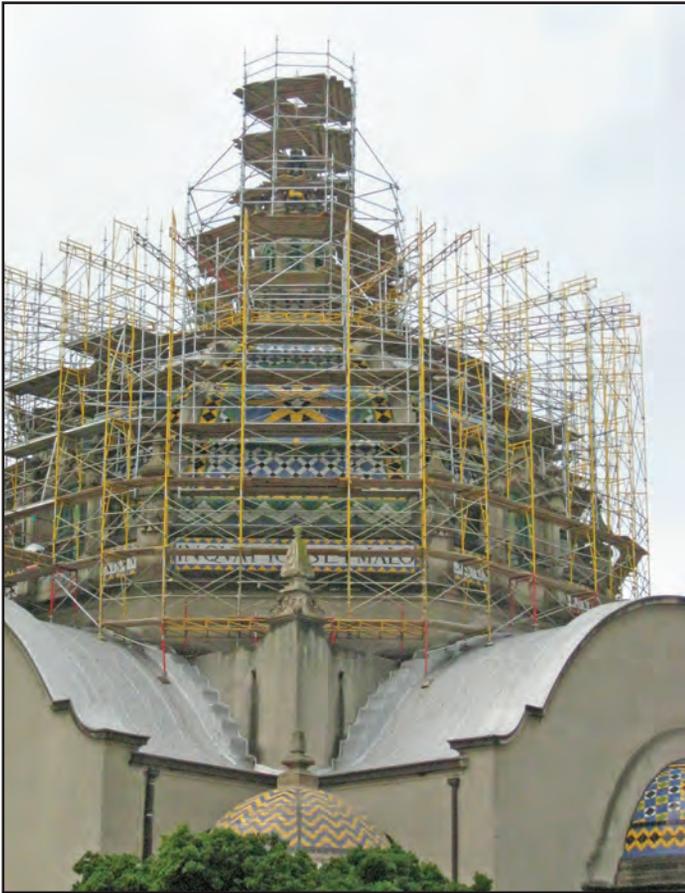
in 1976. Accessing the steeply curved dome requires extraordinary scaffolding to maintain the roof and safely make repairs.

Scaffolding the dome. Photo by Michael Kelly.

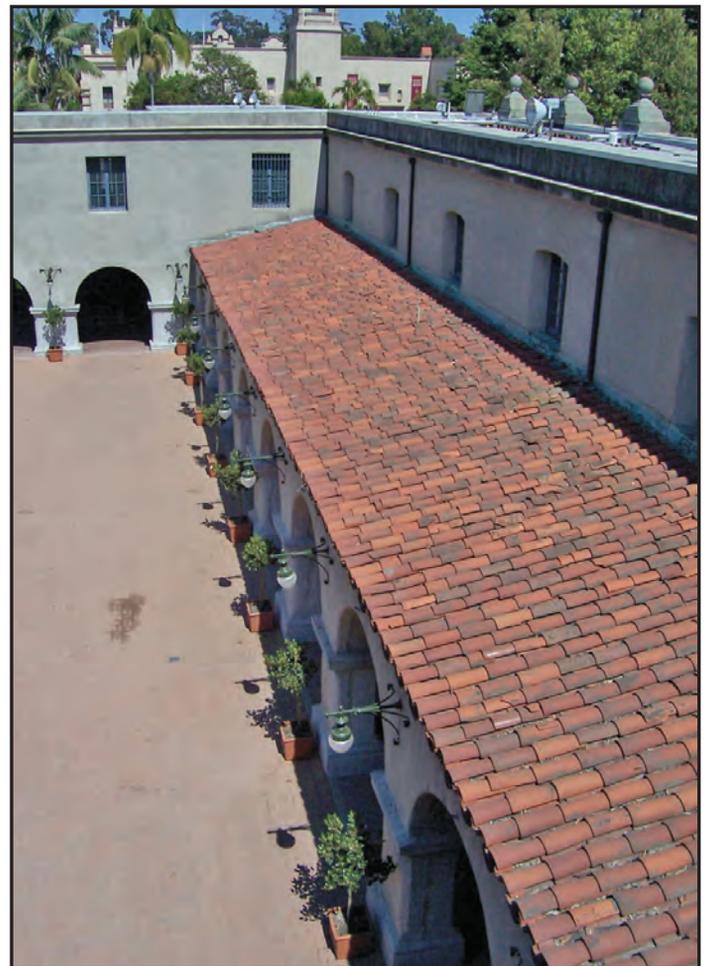
Clay tile roof in the Plaza de California. Photo by Curtis Drake.

The current roofing project also included repair and re-roofing of the clay tile roof in the Plaza de California, reconstruction of the historic carport, and re-roofing of the Administration building adjacent to the California Building. Currently, museum roof repairs are underway and should be completed by April 2012.
